SUBJECT: ASF Report No. 126 - Collapse of Remagen Bridge.

Report on the Collapse of the Ludendorf Bridge, 17 March 1945

INCLOSURE NO.
REPORT ON COLLAPSE OF THE
LUDENDORF BRIDGE

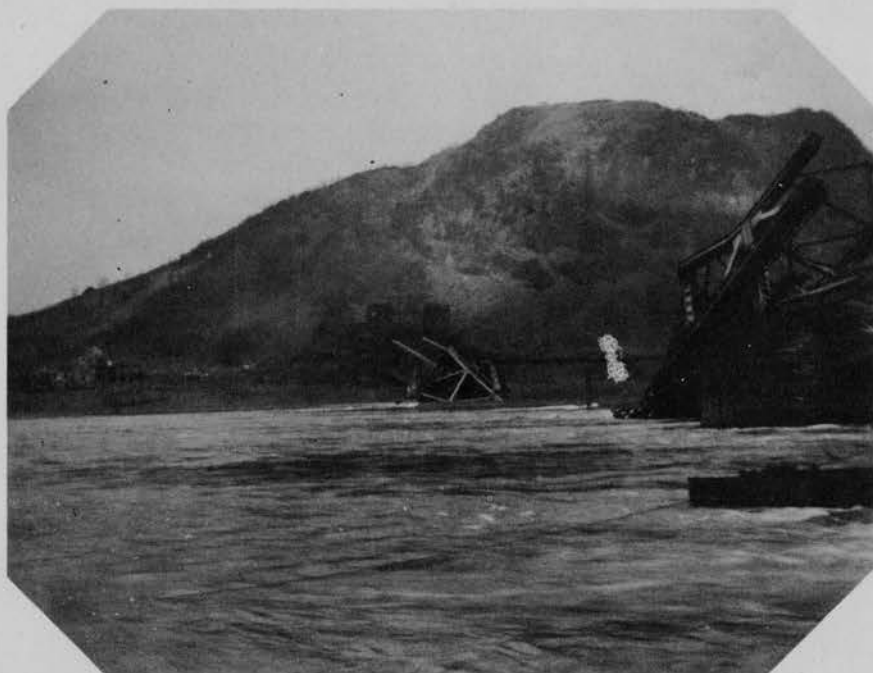
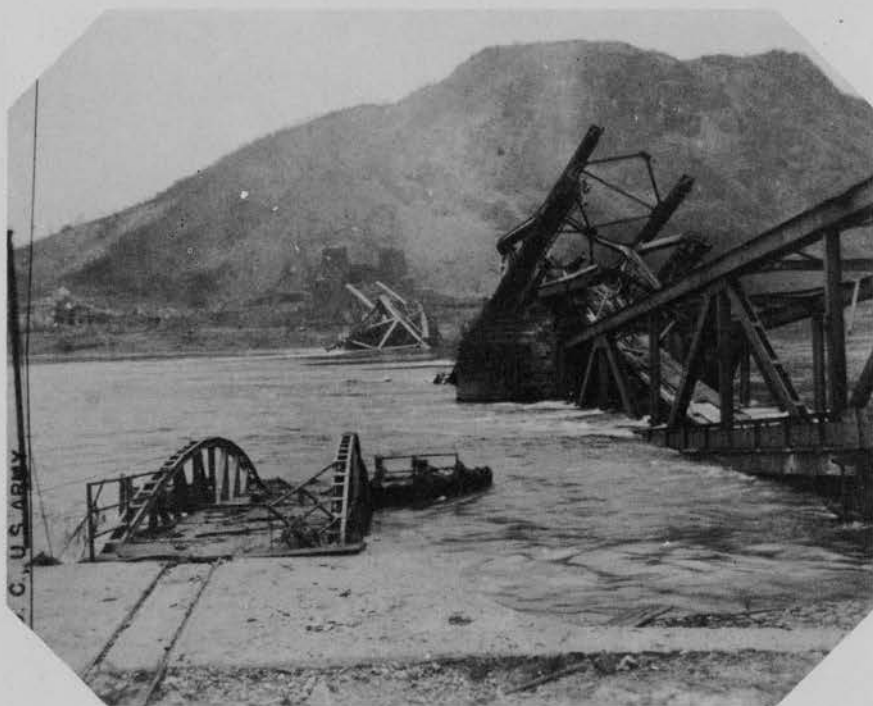
Views of Wreckage from a Point just
downstream from the south abutment

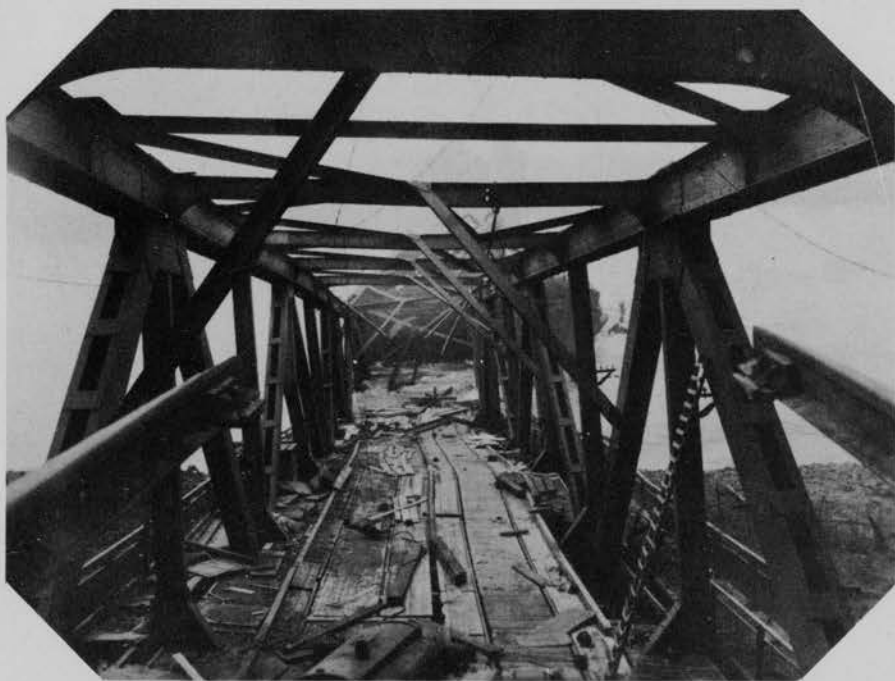
View of Collapsed North Span with
North Pier in the Distance

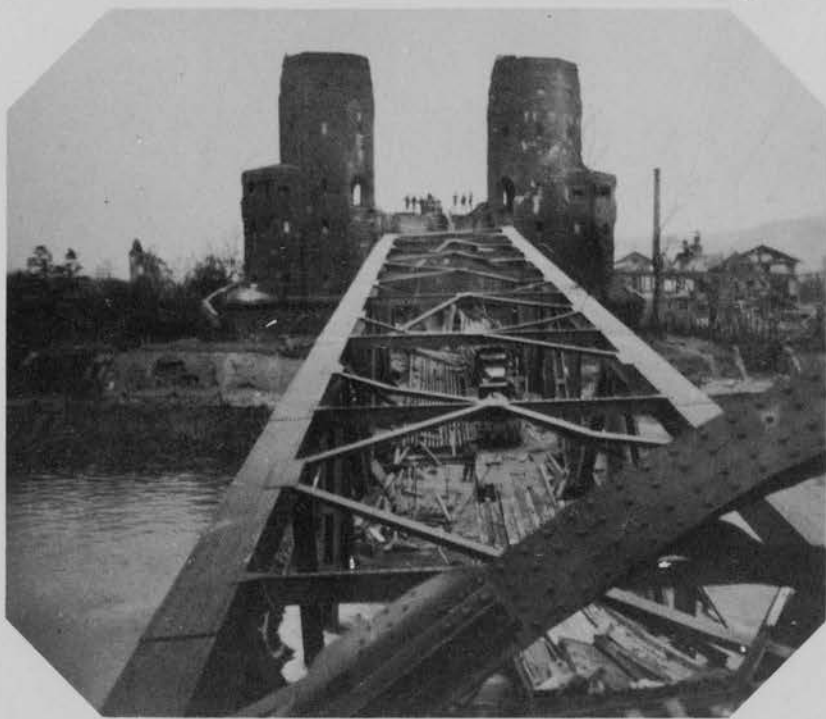
View of Collapsed South Span from
South Pier

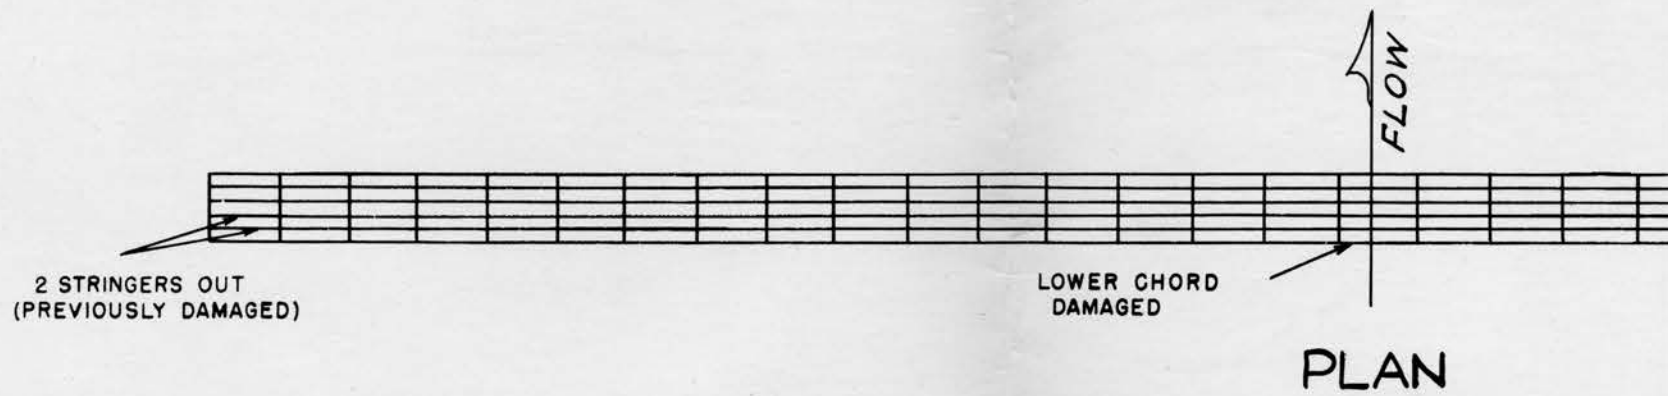
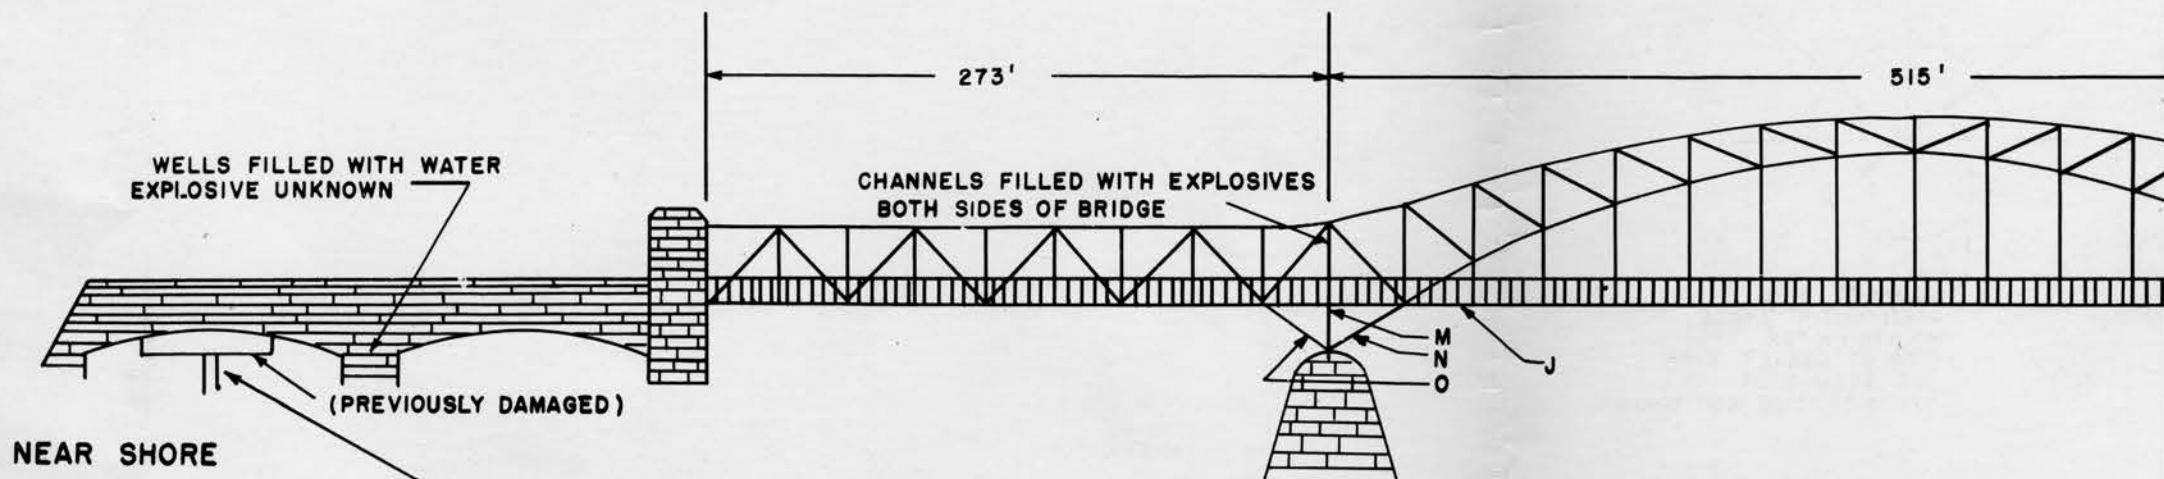
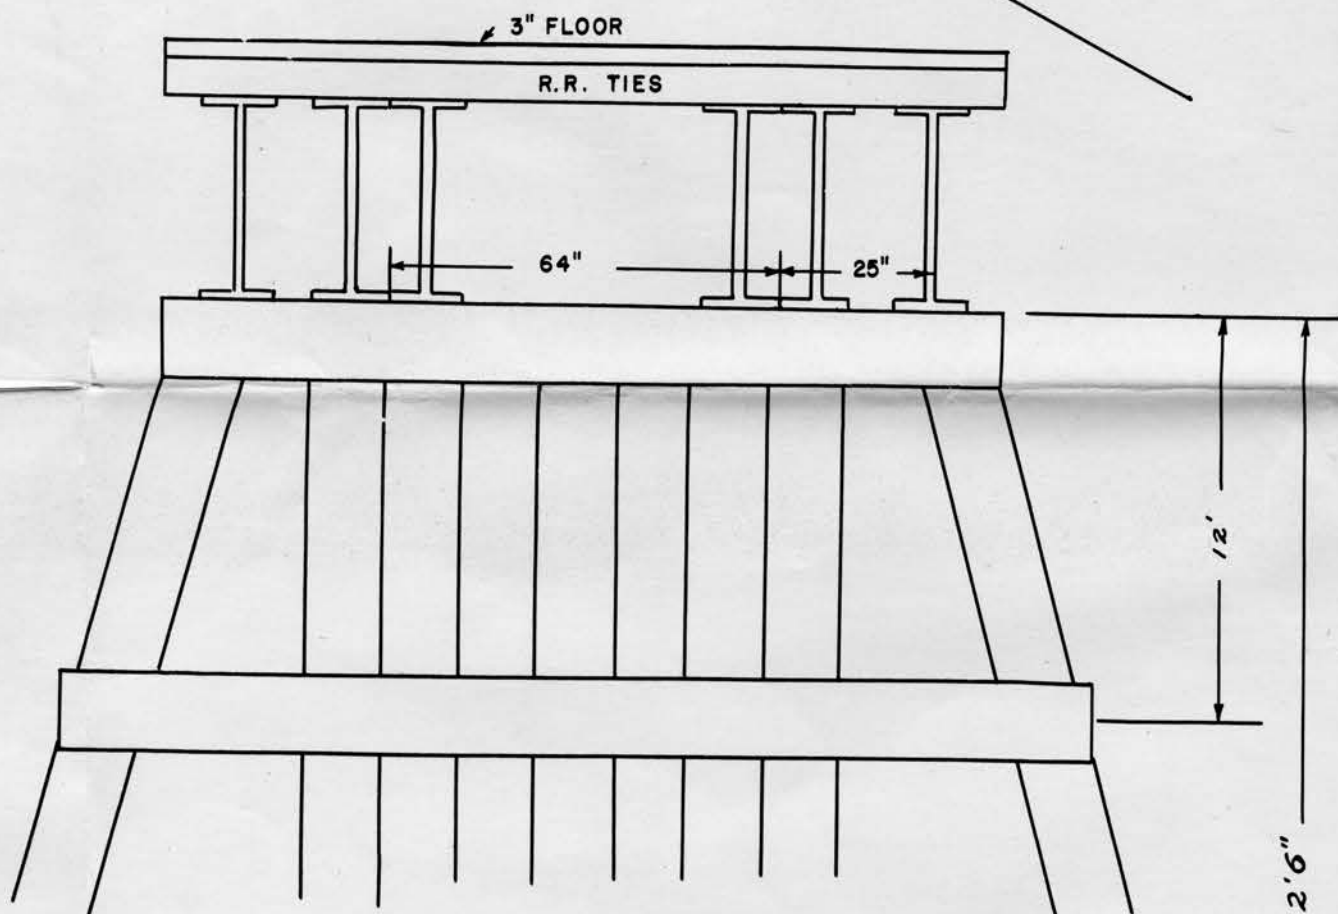
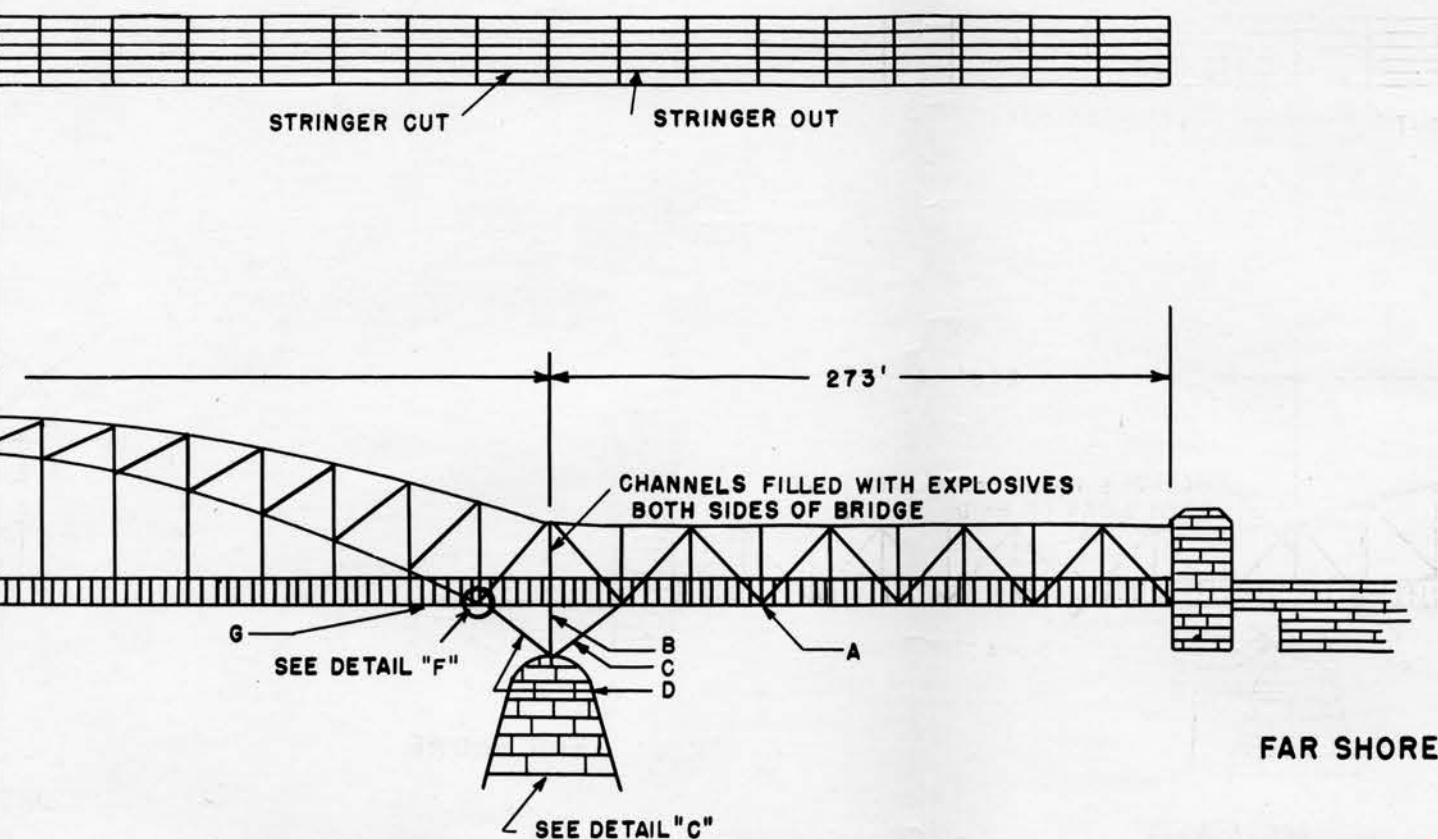
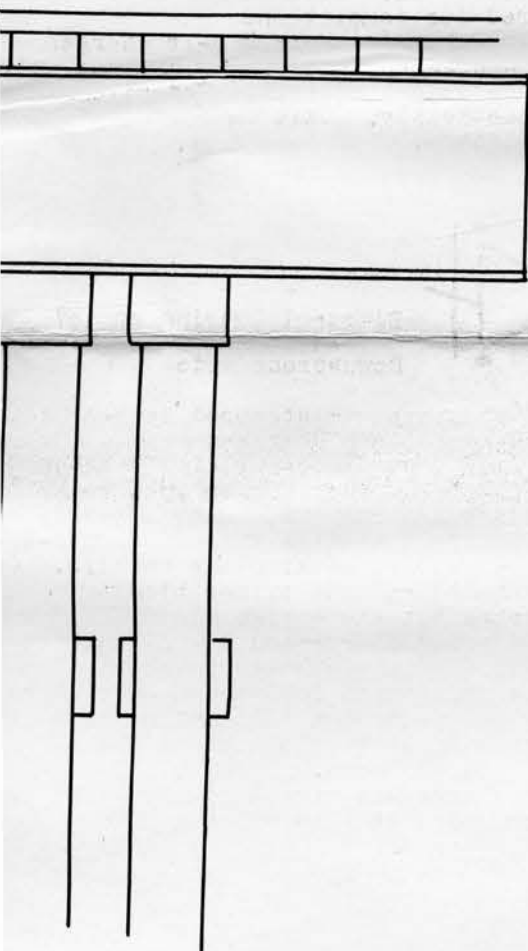
SKETCH SHOWING DAMAGE & DEM

CONSTRUCTION REINFORCING DAMAGED STONE ARCH

THIS WELL CONTAINED 1 CHARGE
APPROX. 2-V2' DIA. 1' HIGH

The charges used on the bridge were all tailored to fit the particular member they were to destroy. They consisted of TNT packed in thin metal boxes and the sizes are all estimates.

a. One 8-lb. charge was located at the junction of the floor beam and the downstream vertical chord at (a). Four other similar charges were spaced along the floor beam at this point. No charge was placed on the upstream chord. Each charge contained an electric cap. Since there were no electrical outlets here it is assumed they were wired with a direct line to the main switch.

b. On each open channel side of member (b) downstream there were 6 - 8-lb charges. Each 8-lb charge contained an electric cap with leads connected to a central outlet box. This member on the upstream side of the bridge was not prepared for demolition.

c. Spaced along member (c) were 2 8-lb charges and 9 - 1 Kilogram charges. Each 8-lb charge was prepared with an electric cap with leads going to separate electrical outlets. The kilogram charges were placed to detonate sympathetically. This member on the upstream side was not prepared for demolition.

At points e and e' there was strapped an 8-lb charge. No electrical outlets were found near these charges.

f. There was an estimated 600-lbs of TNT stacked on all the members which join at point (f). The charges were packed in cardboard boxes whose exact dimensions are unknown. They appeared to be hastily placed and were to be exploded with time fuze and a non-electric cap. The charges upstream detonated and severed the members. On the downstream charge the cap exploded and the primer block was shattered and neighboring blocks disturbed but the charge did not detonate.

g. 1 - 3' x 12" x 10" charge and 1 - 3' x 10" x 6" charge was located on the upstream side of the downstream chord at point (g). 1 - 3' x 12" x 10" charge was on the downstream side of this chord. 1 - 3' x 6" x 12" charge was placed on each stringer. These charges had leads connected to electrical outlets located on the same members. There were no charges on the upstream chord.

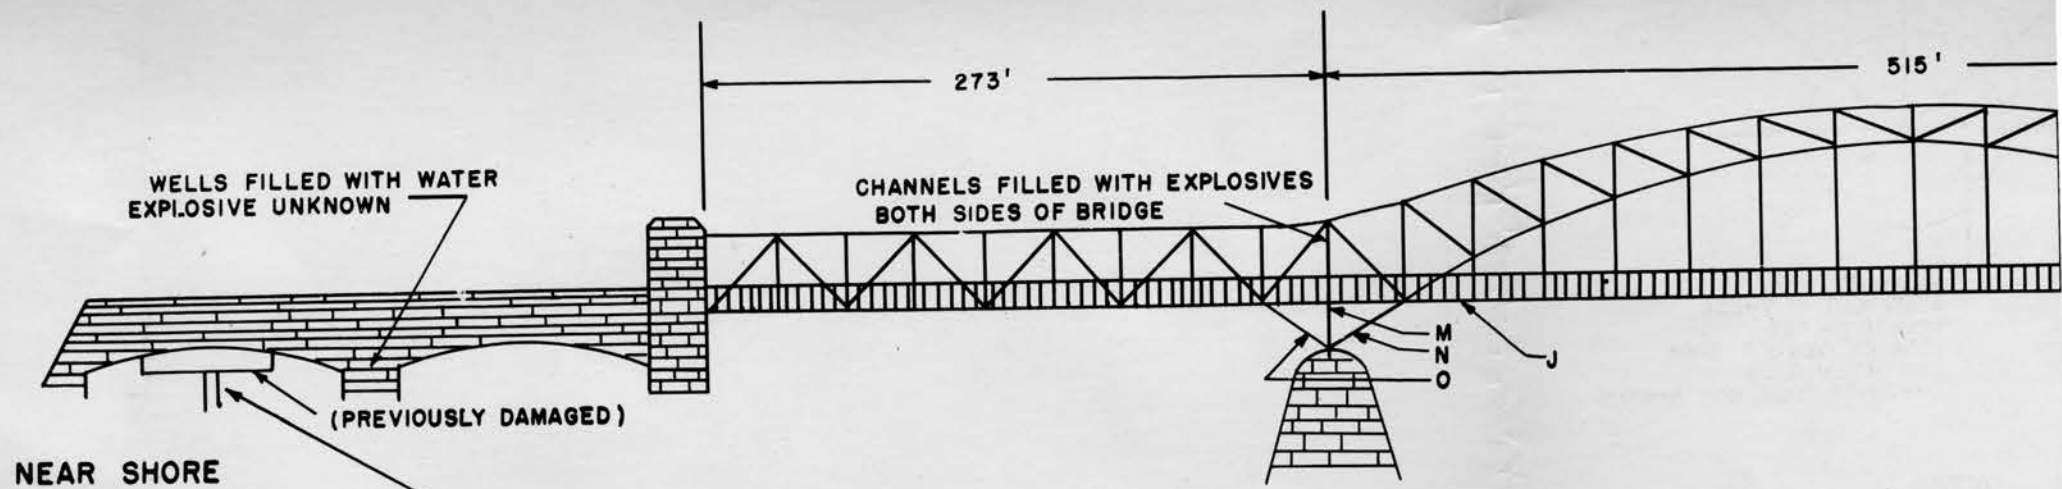
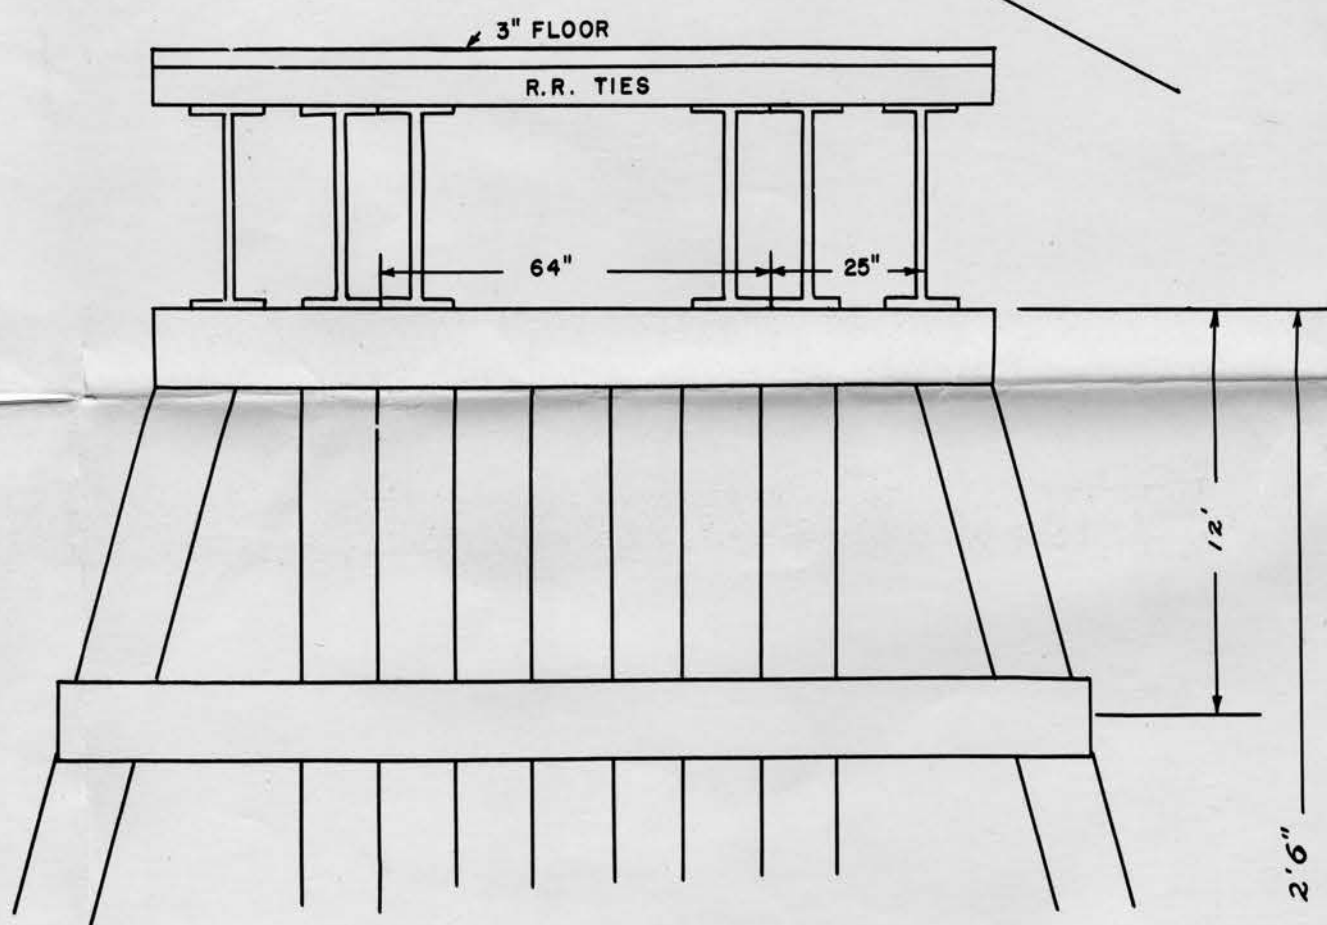
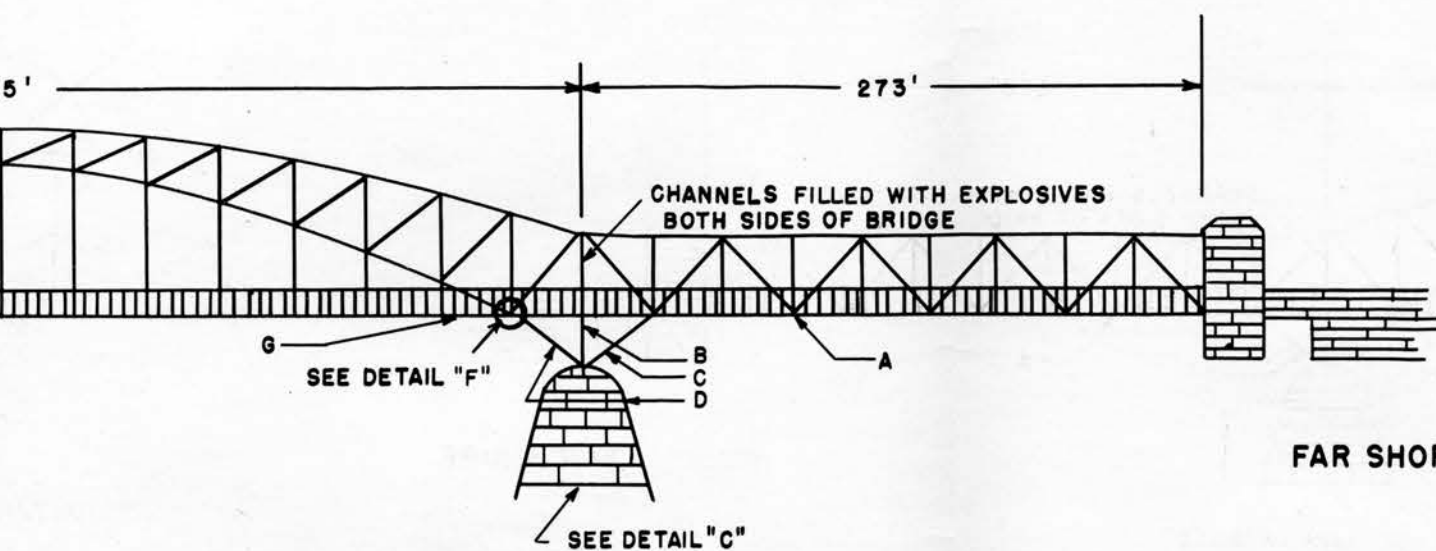
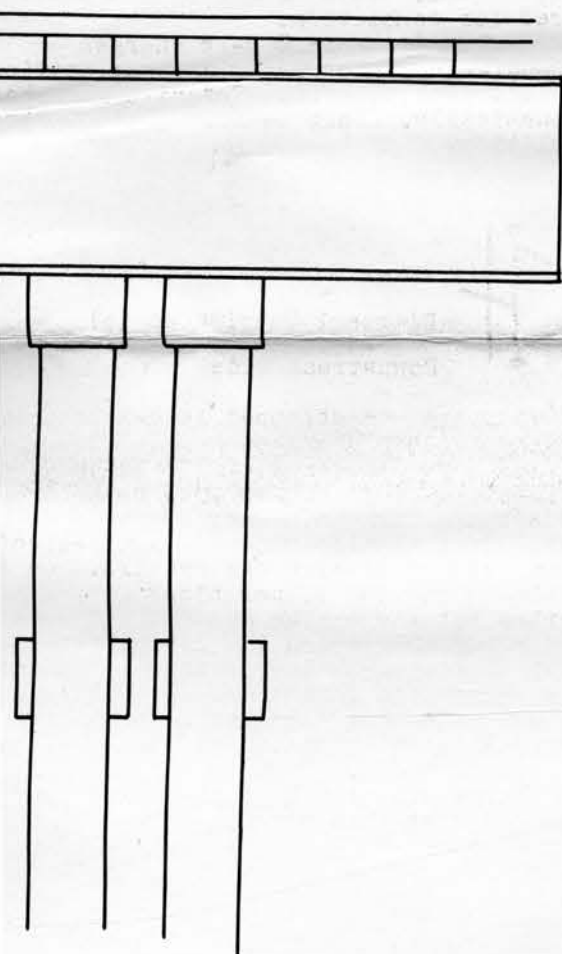
SKETCH SHOWING DAMAGE &

CONSTRUCTION REINFORCING DAMAGED STONE ARCH

THIS WELL CONTAINED 1 CHARGE
APPROX. 2-1/2' DIA. 1' HIGH

THESE TWO WELLS HAVE NOT
BEEN OPENED, NO WIRES LEAD TO THESE WELLS.

SIMILAR PIER, NEAR SHORE
HAS IDENTICAL WELLS WHICH ARE SEALED. NO WIRES.

The charges used on the bridge were all tailored to fit the particular member they were to destroy. They consisted of TNT packed in thin metal boxes and the sizes are all estimates.

a. One 8-lb. charge was located at the junction of the floor beam and the downstream vertical chord at (a). Four other similar charges were spaced along the floor beam at this point. No charge was placed on the upstream chord. Each charge contained an electric cap. Since there were no electrical outlets here it is assumed they were wired with a direct line to the main switch.

b. On each open channel side of member (b) downstream there were 6 - 8-lb charges. Each 8-lb charge contained an electric cap with leads connected to a central outlet box. This member on the upstream side of the bridge was not prepared for demolition.

c. Spaced along member (c) were 2 8-lb charges and 9 - 1 Kilogram charges. Each 8-lb charge was prepared with an electric cap with leads going to separate electrical outlets. The kilogram charges were placed to detonate sympathetically. This member on the upstream side was not prepared for demolition.

At points e and e' there was strapped an 8-lb charge. No electrical outlets were found near these charges.

f. There was an estimated 600-lbs of TNT stacked on all the members which join at point (f). The charges were packed in cardboard boxes whose exact dimensions are unknown. They appeared to be hastily placed and were to be exploded with time fuze and a non-electric cap. The charges upstream detonated and severed the members. On the downstream charge the cap exploded and the primer block was shattered and neighboring blocks disturbed but the charge did not detonate.

g. 1 - 3' x 12" x 10" charge and 1 - 3' x 10" x 6" charge was located on the upstream side of the downstream chord at point (g). 1 - 3' x 12" x 10" charge was on the downstream side of this chord. 1 - 3' x 6" x 12" charge was placed on each stringer. These charges had leads connected to electrical outlets located on the same members. There were no charges on the upstream chord.
