SUBJECT: ASF Report No. 126 - Collapse of Remagen Bridge.

Report on the Collapse of the Ludendorf Bridge, 17 March 1945

INCLOSURE NO.
REPORT ON COLLAPSE OF THE
LUDENDORF BRIDGE

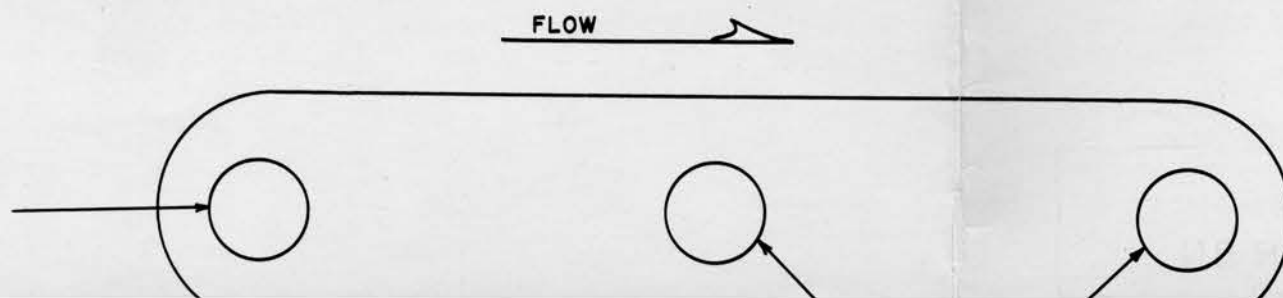
CONSTRUCTION REINFORCING DAMAGED STONE ARCH

THIS WELL CONTAINED 1 CHARGE
APPROX. 2-V2' DIA. 1' HIGH

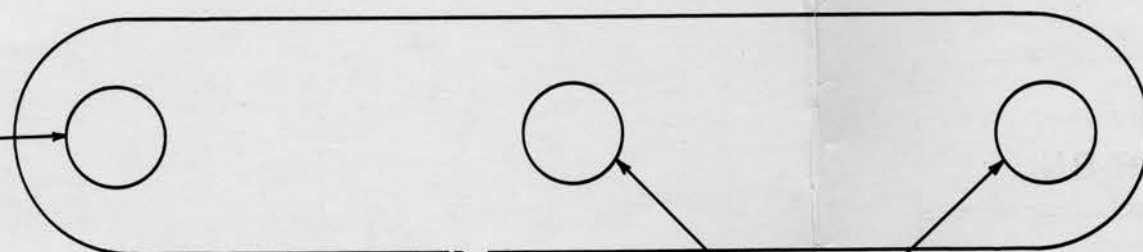
THIS WELL CONTAINED 1 CHARGE
APPROX. 2-1/2' DIA. 1' HIGH

THESE TWO WELLS HAVE NOT
BEEN OPENED, NO WIRES LEAD TO THESE WELLS.
